Forensics in motion - Historic vehicles, genuine or fake?

Gundula Tutt^{a,*}, Sebastian Hoffmann^b

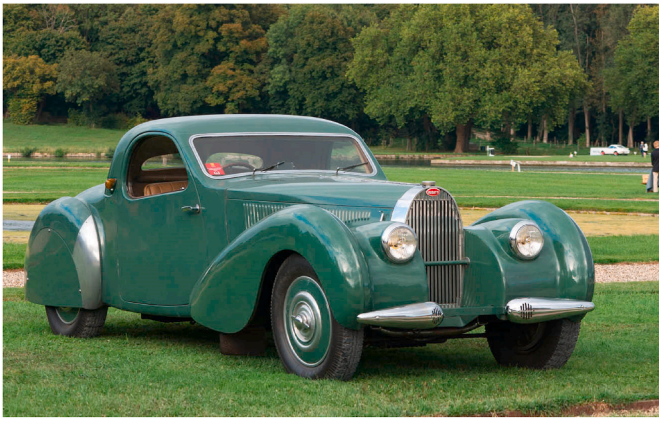
Fig. 1. This 1939 Bugatti T57C with one-off Vanvooren coachwork and in so called unrestored, historically preserved state is a good example for recent developments in the field of valuable collection vehicles. 2013 it changed ownership in a private sale for about \$3 million.²

Vehicles classified as "historic", "monetarily valuable" and "worthy of collection" (like for example the Bugatti T57 in Fig. 1.) usually refer to specific models built between 1886 and the late 1970s. Initially manufactured and used as utilitarian objects and means of transportation, it was standard practice to repair and replace components to keep them functional, or to upgrade or rebuild them as desired in their phase of normal use. Most of them later were ultimately scrapped, but some were just decommissioned and forgotten in a remote garage or barn, after finishing their "service life". At that moment, no one expected that this kind of vehicle "scrap" would some 40–50 years later be considered exclusive again and often traded at higher prices than when it was brand new.

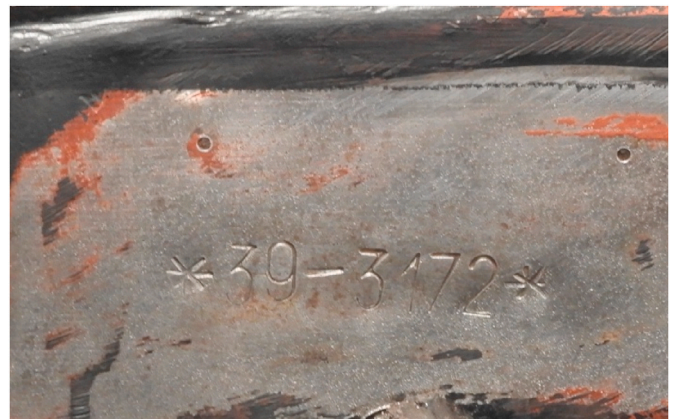
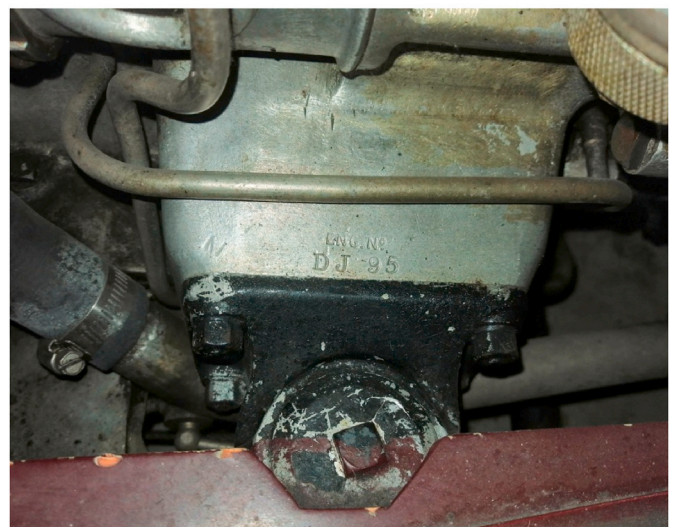
Fig. 2. Numbers stamped on technical components that can identify a vehicle. (a) Original chassis number on a 1938 Lancia Aprilia. (b) Original engine number on a 1933 Rolls-Royce Phantom II.

Alphanumeric combinations were stamped not only into the frame/chassis, but also to the engine, body, the axles and other components. However, the bodies and upholstery, which often were made by outside

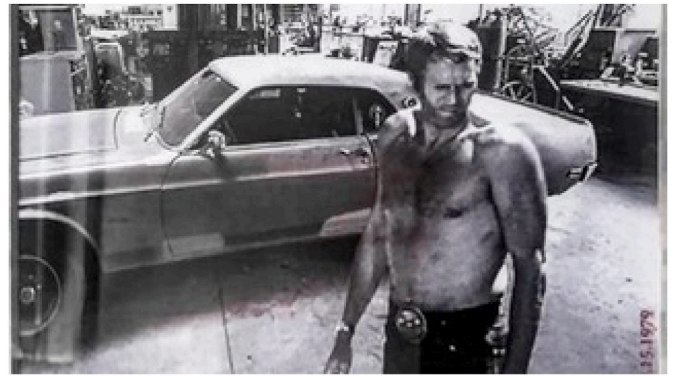
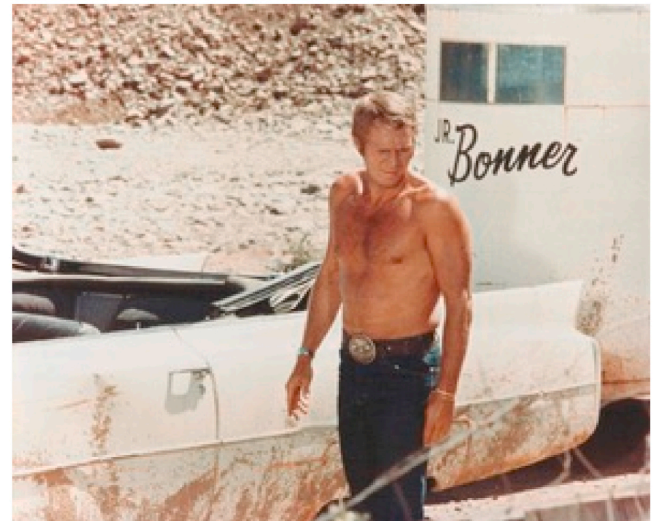
Fig. 3. Manipulations of photo material in the context of collector vehicles. (a) Alleged “proof”-photo for a car claimed to be owned by Steve McQueen, published by BILD online and other media in August 2021.³ (b) Original film still photo from the movie “Junior Bonner”, featuring Steve McQueen in 1972.

In the course of an upcoming auction in October 2021 [16] for example, the “original” picture of a 1969 Ford Mustang Mach I was presented to “prove” the car’s provenance as being from the estate of actor Steve McQueen and the car being in an “unchanged state” since he owned it (see Fig. 3a). The photo was claimed to have been taken by his wife Barbara Minty in 1979. However, a closer look reveals that a 1972 film still from McQueen’s movie “Junior Bonner” was merged with a photo of the car in its current state (see Fig. 3b.). Of course, the way this picture was made up is not very convincing, but the seller obviously tried to put an obscure car in the context of the Ford Mustang GT driven by McQueen in the movie “Bullitt”, which was auctioned for \$3.74 million in 2020 [17].

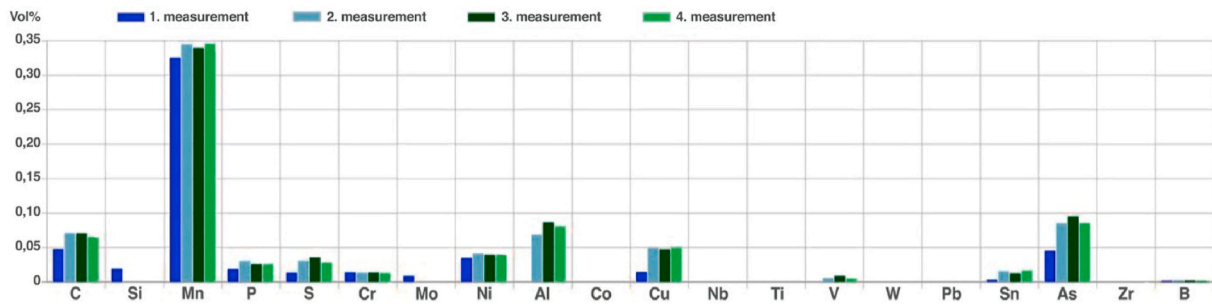
Fig. 4. Material profile of a steel part produced in the early 60s, including four measurements carried out at the corresponding measuring point and relating to 20 different elements.

Usually, several measurements will have to be taken from each measuring point, to exclude misinterpretations due to possible irregularities in the structure of the material (see Fig. 4.).

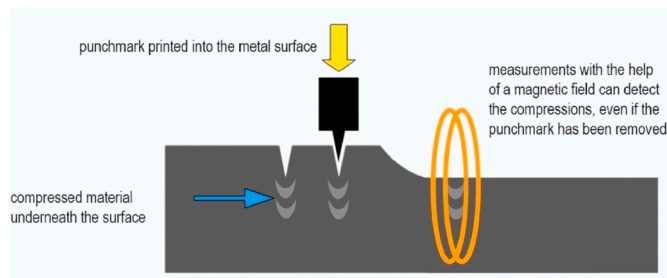
Fig. 5. Scanning a removed punchmark with the help of a magnetic field.

In the case of punched markings made with embossing tools, such as those used on vehicle parts and for applying the identification numbers, the material is deformed not only on the surface, but it is also compressed in deeper layers of the substrate. This means that even if an existing punch marking is mechanically removed, corresponding traces remain in the material underneath and can be made visible again (see Fig. 5.).

The handheld magneto-optical device introduces a strong magnetic field into the substrate. This field penetrates up to 2 mm into the metallic material and is deflected by compacted or inhomogeneous areas in the material. These can be defects in the casting, weld seams or even removed punch markings that are not visible to the bare eye (see Fig. 6 a + b). The digital image generated by the magnetic field measurement not only can visualize extinguished or manipulated original markings, but also allows to match and precisely measure their shape and size.

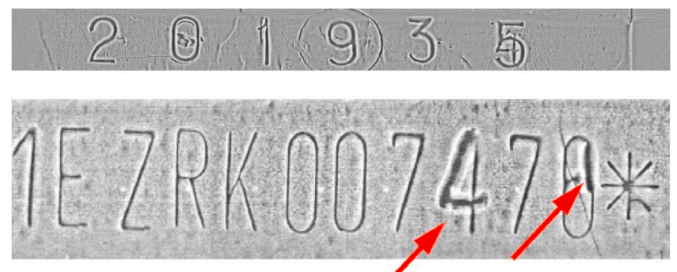
Fig. 6. Using magneto-optical imaging to examine stamped markings in metal substrates. (a) Magneto-optical image of manipulated digits on one of our test-panels: “3” (second left) was sanded out and restamped with “0”. “6” (4. left) was cut out, the cut segment turned by 180° and re-inserted to make it a “9”. “4” (far right) was stamped over to make it a “5”. (b) Magneto-optical image of manipulated digits in an original vehicle identification number (see red darts): “6” (far right) was changed to “8”. “1” (4. right) was restamped to make it look like “4”. (For interpretation of the references to color in this figure legend, the reader is referred to the Web version of this article.)

Extensive testing together with Zetos GmbH have shown that related devices can also be applied to historical vehicles. They enable fast and non-destructive verification of the chassis or engine numbers even on painted components. The use of this technique is limited only by the

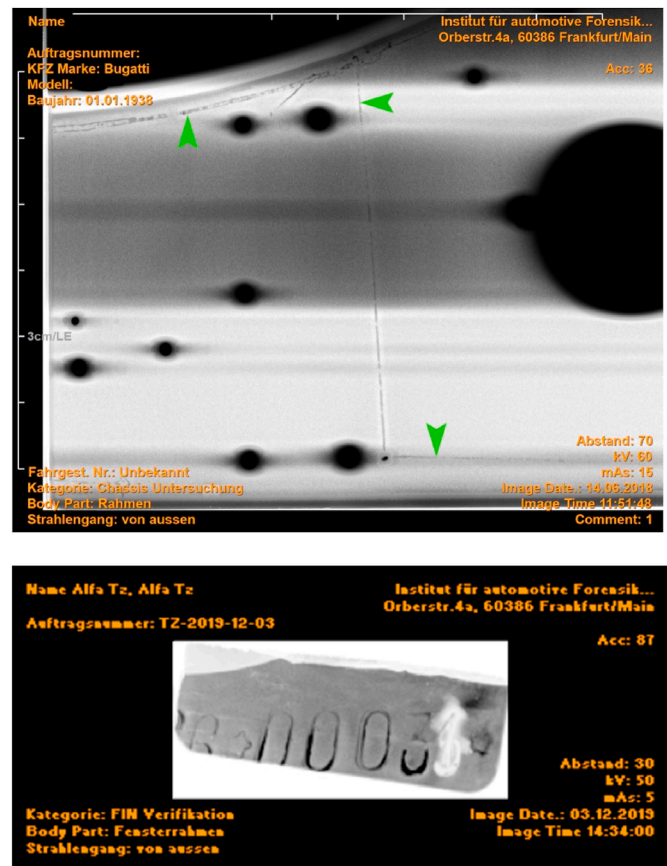
Fig. 7. Manipulations made visible using X-ray imaging. (a) X-ray image of an allegedly original Bugatti chassis, which clearly reveals welding seams (see green darts). This proves the chassis has not been made using the production processes used by the factory. (b) Manipulation on an Alfa Romeo SZ. The "1" in the chassis number (far right) was filled with tin and stamped over with "5". (For interpretation of the references to color in this figure legend, the reader is referred to the Web version of this article.)

Assembly of a chassis with the welding method does not require the industrial equipment and stamping tools used by the manufacturer in period. Instead, the welding method is frequently used in later reproductions. In addition, other indicators that were found on this particular chassis, such as its material composition pointing to the 1960s, confirmed that it was not an original Bugatti component [32].

In a different case, the examination of a famous Porsche racing car from the 1970s has shown the potential of X-ray examinations beyond just looking on the chassis/frame. It is documented that this vehicle underwent various modifications during its life, which included special parts added onto the roof. The large-scale X-ray of the roof, which today appears smooth and seamless, revealed no traces of earlier equipment that had been mounted nor traces that the mounting holes had been covered later. Together with other inconsistencies regarding the materials used and the existing identification markings, this led to the clear conclusion that this car was not the original racing car [33].

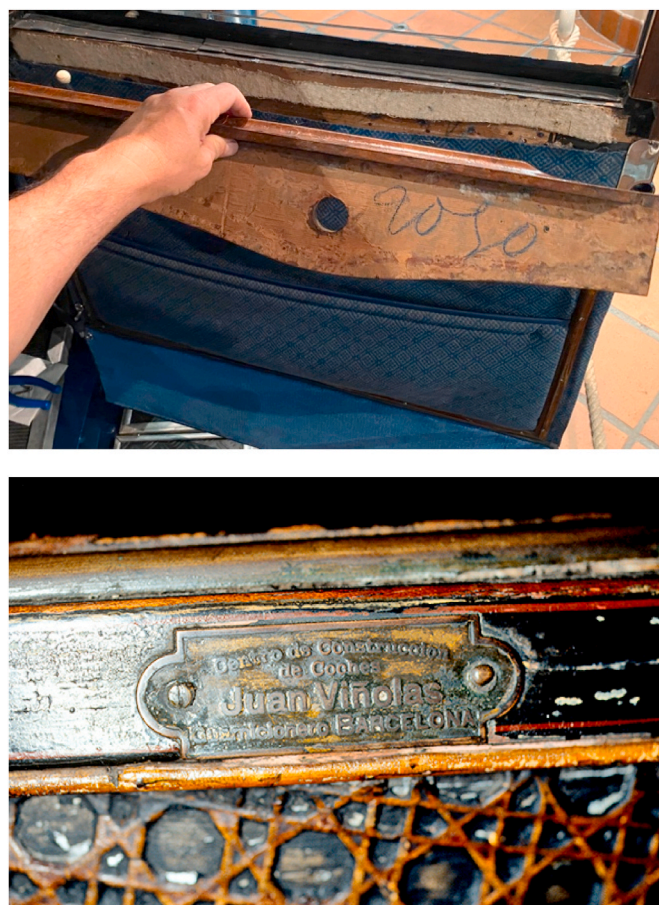
Fig. 8. Historical markings can help to clarify the local and chronological context of elements and materials preserved on a vehicle. (a) Body number 2090 of a 1931 Delage D8L, applied by the upholsterer during the production process with blue wax crayon on the back of a wooden interior trim panel. Such markings, both how they were applied, and their location can give clues to the manufacturer of the body, its upholstery and interior trim, as well as to their initial affiliation with the vehicle in question. (b) A coach builder’s plaque on a 1900 Renault type C, relating to body modifications commissioned by the first owner located in Spain. (For interpretation of the references to color in this figure legend, the reader is referred to the Web version of this article.)

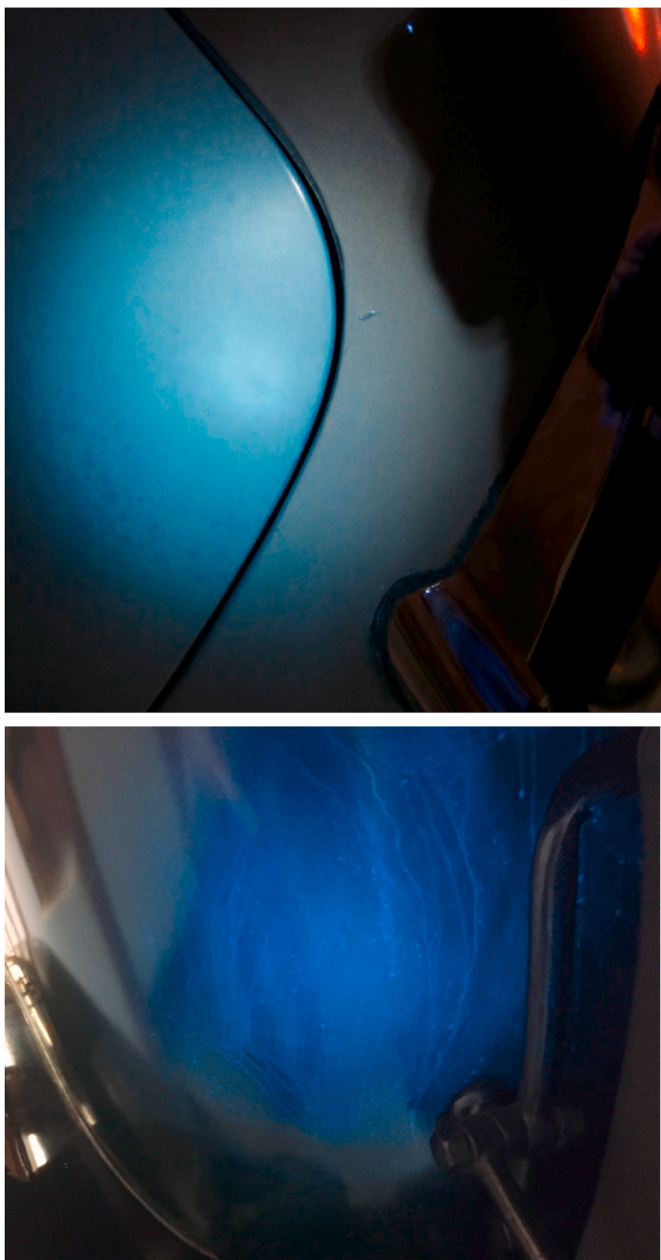
Fig. 9. With the help of UV radiation, repairs and other treatments to the vehicle paint, interior trim and other surfaces can be made visible. (a) Deviating fluorescence under UV radiation reveals the hood (left area on the picture) of a Jaguar E Type has been repainted. (b) UV radiation shows sags and brush marks in the “patina” of a Rolls-Royce Silver Ghost, indicating that its dark, supposed “antique” surface has been intentionally applied.

The initial inspection often reveals important hints of earlier modifications and refurbishing, such as modern staples, fasteners, springs or screws, or paint running over rubber window seals and into cracks in the deeper layers. Further insight can be obtained by using a head loupe or a stereo microscope and different light sources, like UV radiation or grazing light. As with the examination of paintings, paint repairs (see Fig. 9a) as well as partial replacements or repairs to seat covers, carpets and other parts of the interior can be identified in this way. In many cases, UV radiation can even help reveal runs, and fine brush and wipe marks, in the seemingly venerable “patina” of a surface, which indicate that it was artificially created (see Fig. 9b).

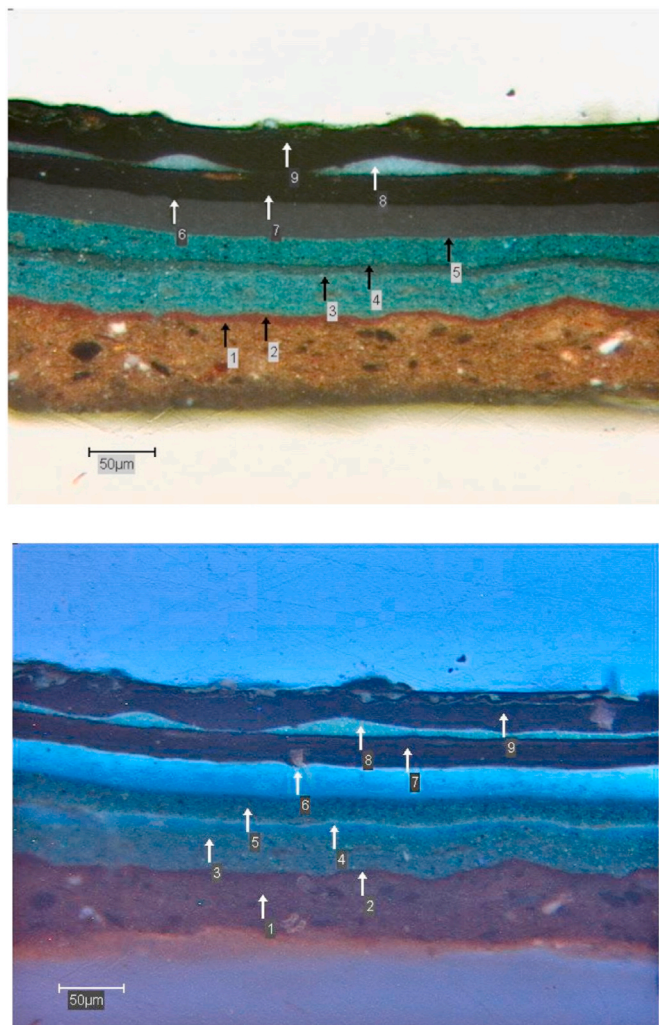
Fig. 10. Microscopic cross-section of the first, fishsilver-green paint scheme on a 1934 Mercedes 500 K (layers 1–6), - this first paint phase later was over-painted twice in black (layers 7–9). (a) The coating layers in the visible light spectrum. (b) Looking at the cross section using UV radiation (wavelength 365–380 nm), which can make details more clearly visible. (For interpretation of the references to color in this figure legend, the reader is referred to the Web version of this article.)

Typically, a macroscopic and microscopic examination of the samples and their cross sections is performed. Depending on the case, reflected light, transmitted light, polarization microscopy and UV fluorescence microscopy can be used. The findings directly visible in the cross-sections, such as the sequence of layers, characteristic coatings and grain structures or distinctive UV fluorescence, are recorded in writing and documented photographically (see Fig. 10 a + b).
